ESOM I and II Final Report

Alessandro Bocconcelli, Henri Berteaux, Daniel E. Frye
and Dr. Bryce Prindle

Woods Hole Oceanographic Institution
Woods Hole, Massachusetts 02543

November, 1991

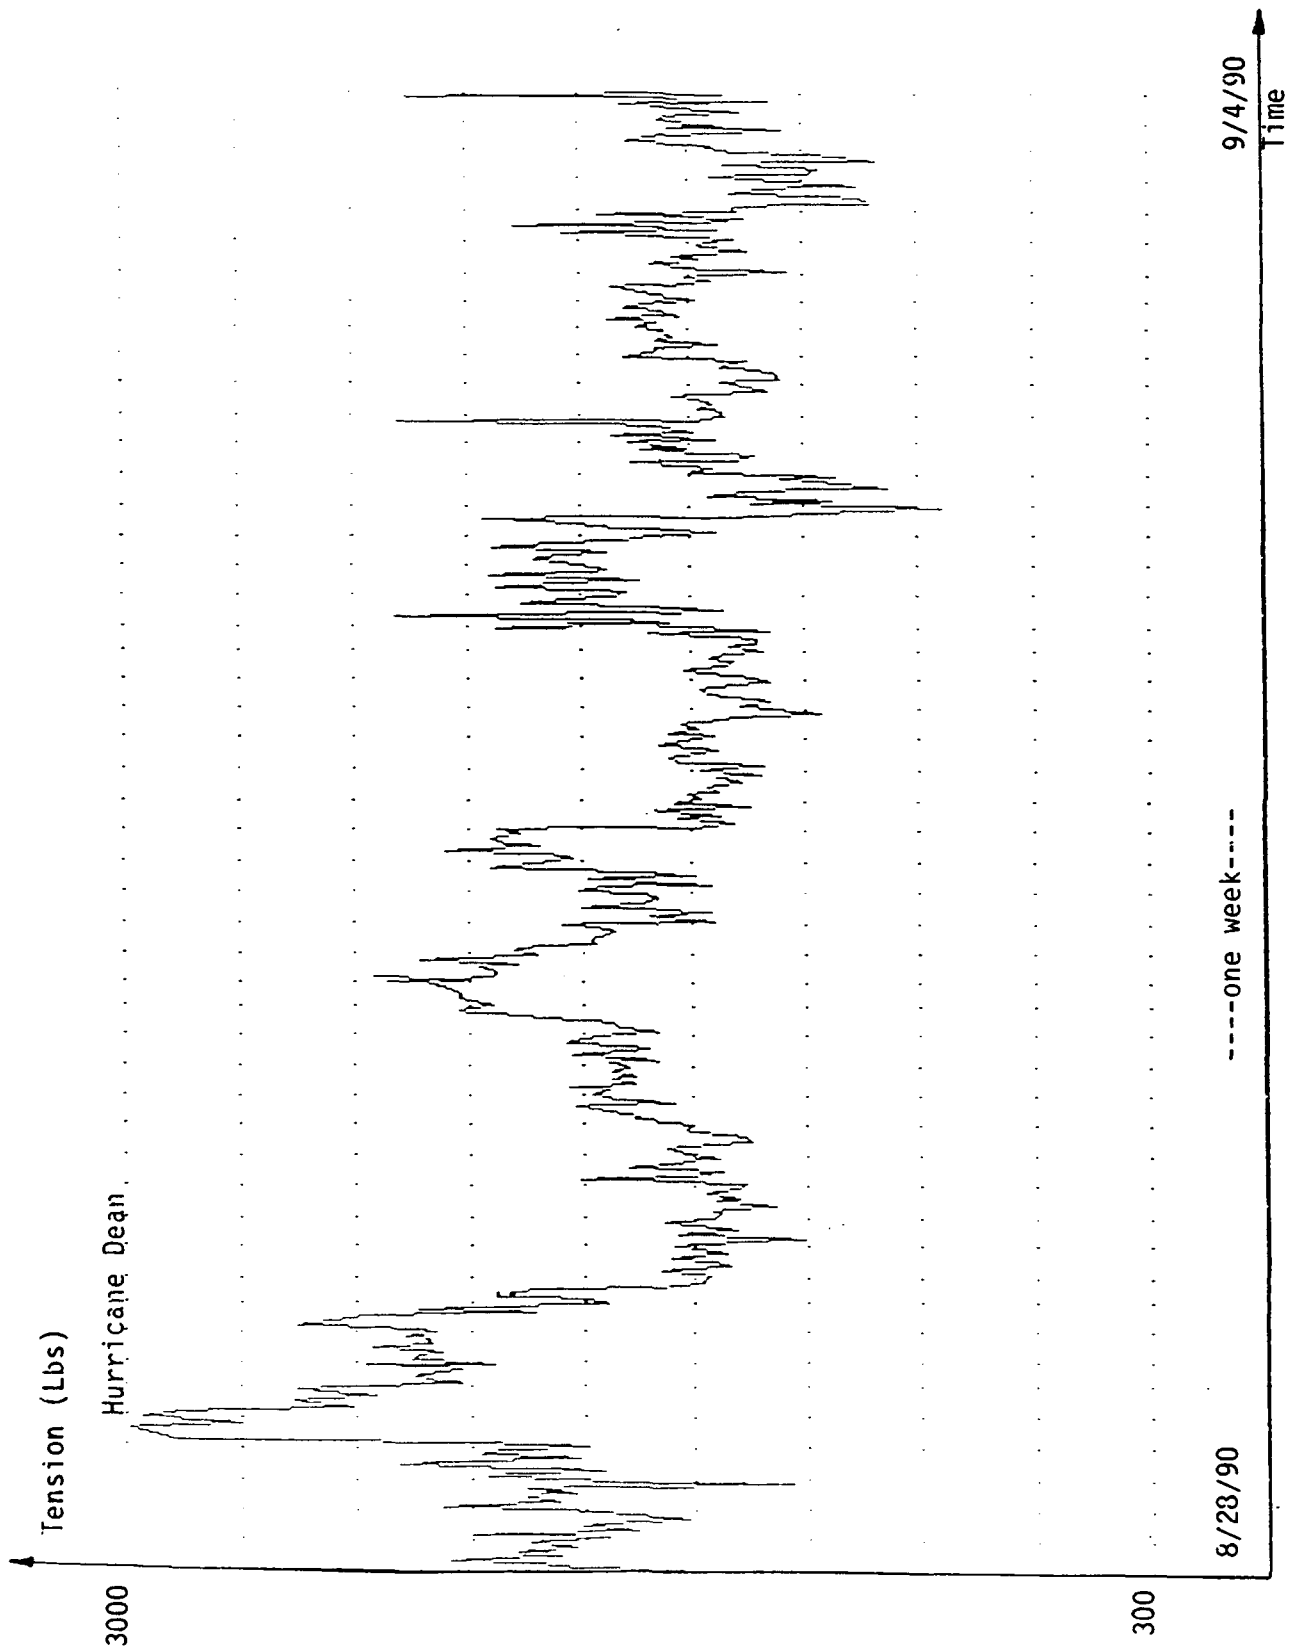
FIGURE 9: Tension cell data

A Teledyne Model 12367-20K tension cell, with a maximum capacity of 20,000 lbs, was mounted at the bottom of the surface buoy and connected through a shackle to the mooring. This sensor was carefully calibrated at WHOI prior to the deployment. Surface buoy tension data was transmitted daily to WHOI through ARGOS, to monitor buoy performance (Figure 9). When the surface buoy went adrift, the tension data clearly indicated a failure on the mooring line.

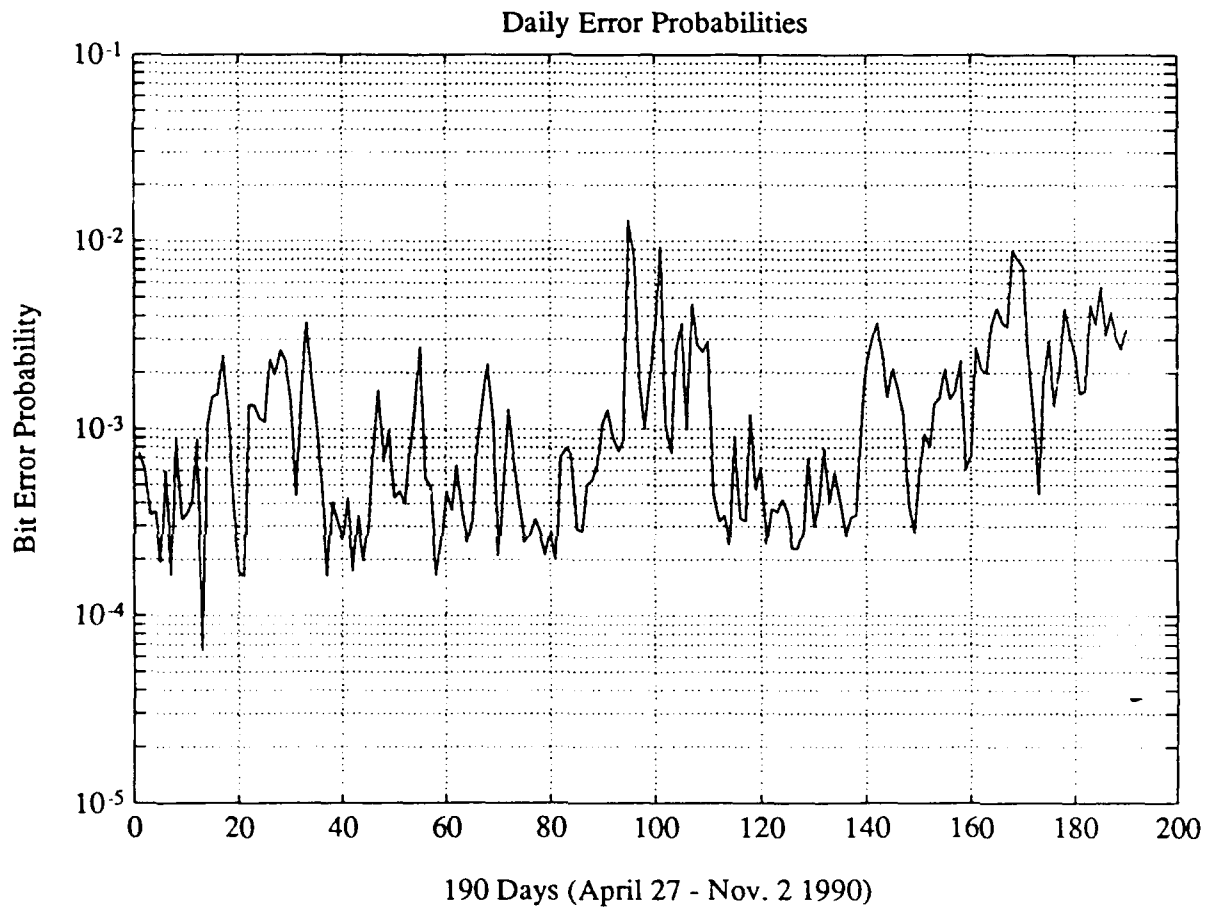
FIGURE 16: Data record from modem at 1500m

After the modem lowering, the ESOM buoy was installed and data were collected regularly over the next six months. Figure 16 (from [14]) show results from the modem deployed at 1500m. This modem operated for the full six month period and transmitted over 20×10^6 data bits at a BER that ranged from 1×10^{-2} to 1×10^{-4} and averaged 1.45×10^{-3} . The other two modems operated much less consistently. The modem at 300m was damaged prior to or during deployment and suffered from a reduced transmit power level. As a result, its performance was marginal. The deep modem, deployed at 2900m failed after 32 days due to an electronic problem. During the time it operated, the average BER for its transmission exceeded 10% and its SNR was of the order of 2 dB, well below the performance level expected based on data from the shipboard lowering. Analysis of the system performance following the mooring retrieval suggests that high levels of surface-generated background noise masked the signal from the 2900m modem. Signal strength from the 1500m modem was higher and its data were seriously degraded much less frequently. Typical SNR for the 1500m modem was 10dB.

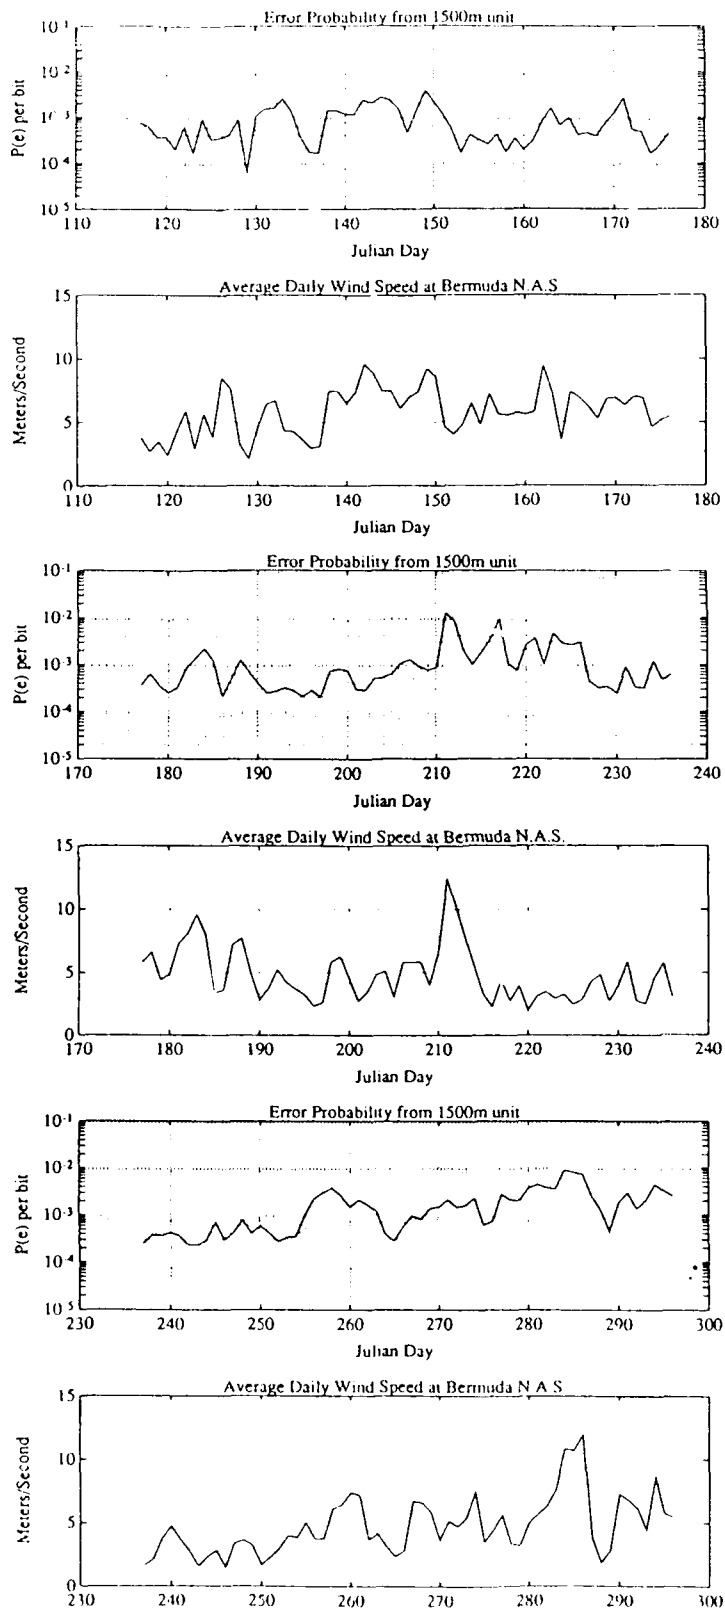
FIGURE 17: Wind speed and error probability data record

The source of the noise is believed to be surface waves and their interaction with the surface buoy and the hydrophone mounting system. This conclusion is based on data shown in Figure 17 (from [14]), which shows daily averaged wind speed at the Bermuda Naval Air Station (20km north of the mooring site) plotted above daily average BERs for the 1500m modem. A clear correlation between high average winds (and presumably high sea state) and high BER is evident.
